HIVE CLX Troubleshooting Guide

//// Overview

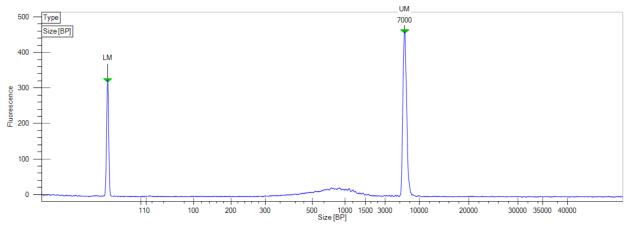
Issue: Low library yield (at or below 1 ng/ μ L) for user-loaded HIVE but CLX 1st strand control has product

DNA quantification is at or below 1 ng/uL; DNA gel electrophoresis traces appear normal with a smooth smear and the correct peak but may be hard to distinguish due to low input.

Potential cause:

- Poor sample preparation
- Sample is incompatible with HIVE scRNAseq

Severe sample preparation, capture, or processing failure Recommendation:

- There is enough product generated from the WTA reaction to run multiple Index PCR reactions. The Processing Kit provides enough reagents to perform three rounds of Index PCR and SPRI Clean-up for each HIVE
- o Repeat the Index PCR and SPRI Clean-up steps
- o If repeating the Index PCR does not fix the problem, start a new HIVE for the sample
- It may be difficult to discern low or no library yield issues due to measurement device sensitivity, non-specific signal, and how severely a step is compromised.

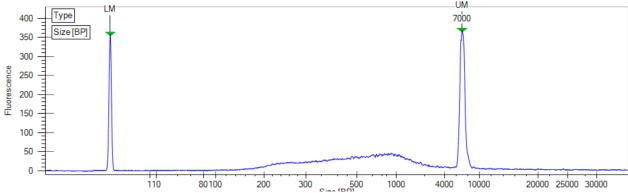
Issue: Flat and broad trace with extended left slope

DNA quantification is around the threshold or at the lower end of normal range. DNA gel electrophoresis traces appear to show a smooth smear with a correct main peak, but overall show a flat pattern with the elevated left slope extending to 200 bp.

Potential cause:

- Severely compromised library preparation operations, for example:
 - Used incorrect buffer
 - Omitted NaOH denaturation
 - Missing Clean-up enzyme or disrupted incubation

- o Rerun the WTA SPRI Clean-Up, Index PCR and Index SPRI Clean-up
- Do not sequence if repeating Index PCR does not solve the issue. Sequencing data quality likely will be poor.

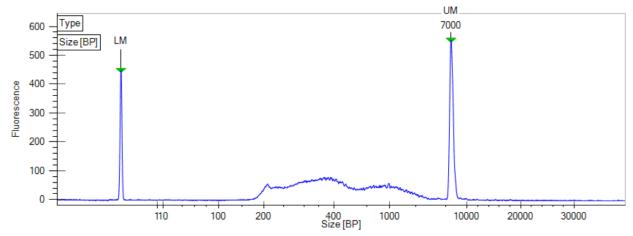
Issue: Broad trace with multiple main peaks

DNA quantification is around the threshold or at the lower end of normal range, and DNA gel electrophoresis traces appear to show a continuous smear with multiple main peaks.

Potential cause:

- Severely degraded sample RNA
- 1st Strand synthesis reaction failure (such as missing enzyme)
- Other significant library preparation failures

- o Rerun the WTA SPRI Clean-Up, Index PCR and Index SPRI Clean-up
- Do not sequence if repeating Index PCR does not solve the issue. Sequencing data quality likely will be poor.

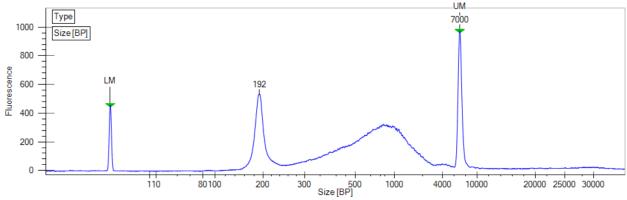
Issue: There is a spike around 200bp

DNA quantification is normal, and DNA gel electrophoresis traces appear to show a smear with the correct main peak, except that there is a sharp spike around 200bp.

Note: This spike may significantly reduce effective sequencing reads due to its small size therefore much higher molecule allocation than the gel trace signal.

Potential Cause:

- Inherent cell type trait (small peak sometimes seen with PBMCs)
- Using too much WTA product for Index PCR, for example more than 5 ng
- Failed SPRI Clean-up, such as:

- adding more SPRI Beads than recommended
- Skipping the WTA SPRI Clean-Up

- o Redo WTA SPRI Clean-up if skipped or correct steps were not followed
- o Index PCR within recommended limits (5ng or less WTA input)
- o Redo the Index SPRI Clean-up if correct Index PCR conditions were followed but:
 - · correct steps were not followed -OR-
 - this spike is very large (either the spike height is higher than half of the main peak height or its area under curve (AUC) is over 10% of total)
